**PENNSYLVANIA  
ID NO. PA.00688**

# **LOWER TUMBLING RUN DAM**

## **PHASE I INSPECTION REPORT NATIONAL DAM INSPECTION PROGRAM**

**AUGUST 1978**

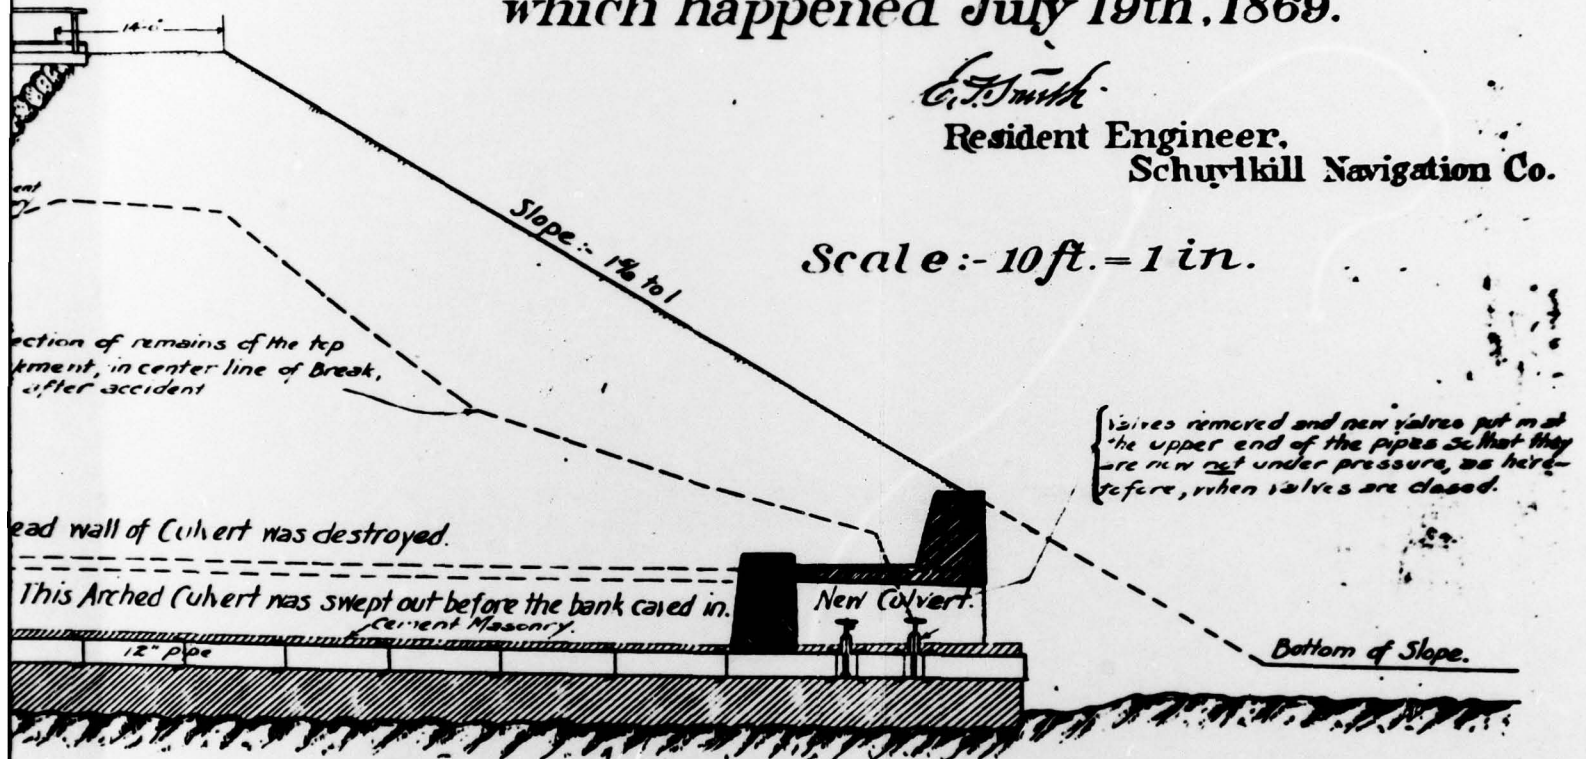
PLATE 4

Before 1869, the water supply pipes were always under full hydrostatic head. These pipes apparently cracked and the resulting leakage was large enough to cause piping and eventual embankment failure in 1869. As shown on Plate 4, the top of the dam dropped 10 feet. The pipes were repaired, encased in concrete for part of their length, and the valves moved to the upstream end of the pipes.
